# Manhole Inspection Summary

Manhole # S31UU1018MH

Insp Date: **1/16/07 9:27 AM**

**Location** Address: **102 GOODALE RD**

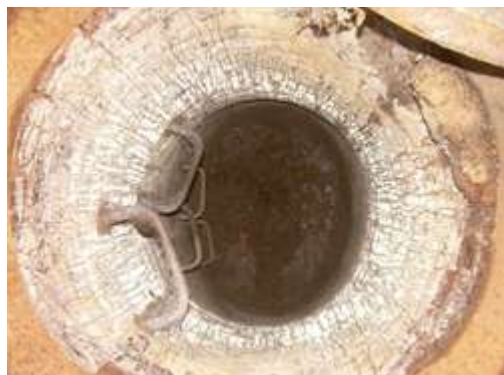
Top View

Channel debris.

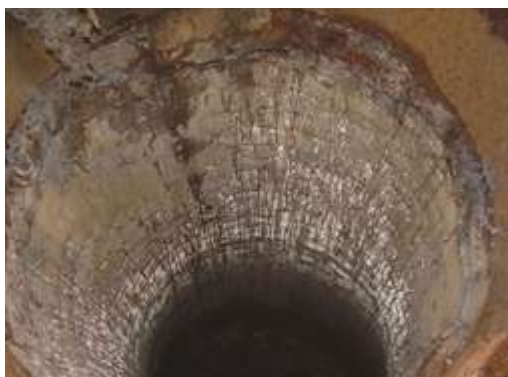
Defect

Adjustment deterioration and infiltration. Corbel and Barrel infiltration - other side.

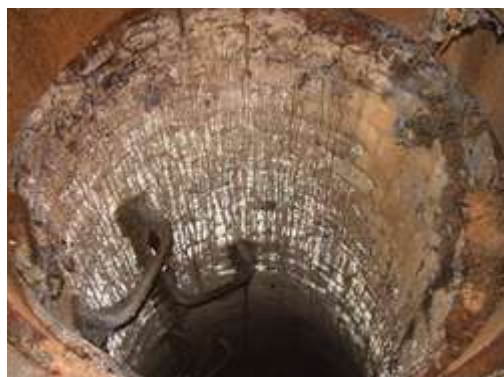
Defect

Frame offset. Adjustment deterioration and infiltration. Corbel and Barrel infiltration.

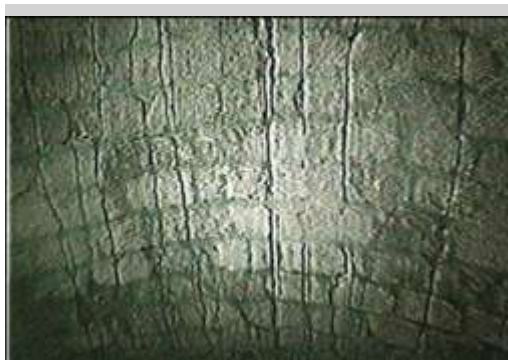
Defect

Barrel infiltration.

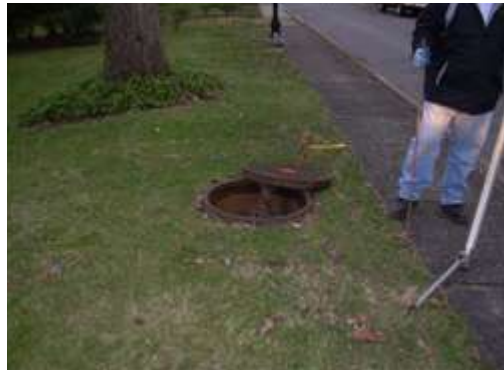
Defect 5

2 " above grade.

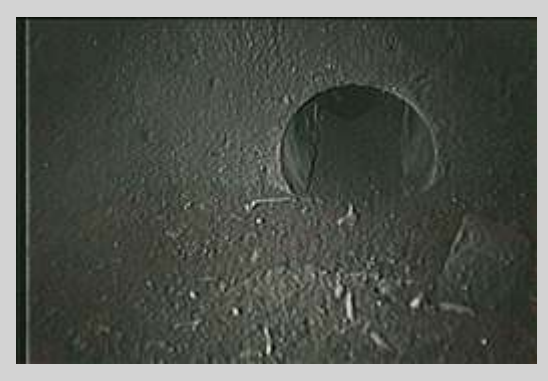
8 in. Circular Gravity Sewer  
Pipe Out @ 12 O'Clock

Deposits: ☐ None ☒ **Mud** ☐ Sludge ☒ **Debris** ☐ Grease

Silt Depth: **0.5** (in.) Deposits Extent: **Light**

Infiltration: **None** Pipe Seal Cond: **Cracked**
